Summary of Pipe Spring™ Full Scale Testing

Introduction

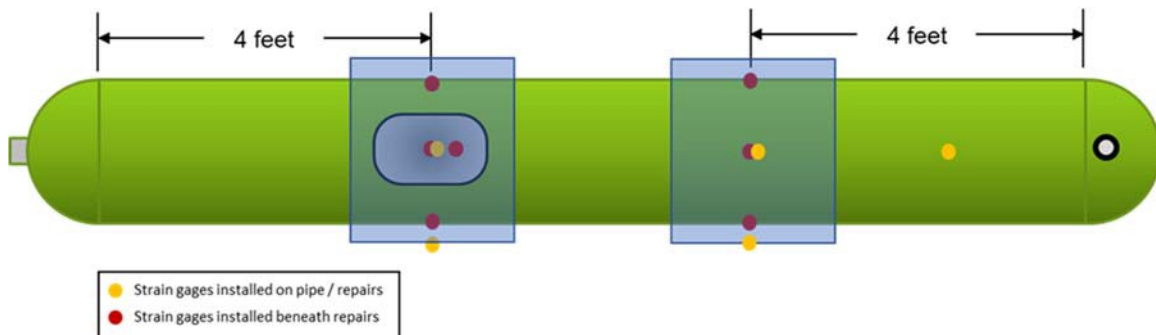
Schematic 1: Installation Diagram

Two Pipe Spring installations were completed and tested on one section of nominal X42, 12-inch diameter, .375-inch thick steel pipe. One unit was installed over a significant metal loss defect. ADV Integrity's report refers to this unit as the "Corrosion Pipe Spring". One unit was installed on solid pipe with no known defect present. ADV Integrity's report refers to this unit as the "Effective Modulus Pipe Spring." The schematic below demonstrates the set up.

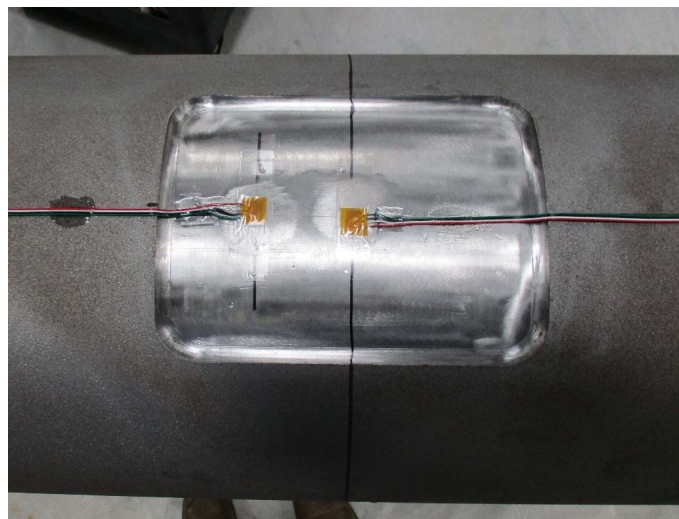
Image 1: Biaxial strain gages installed in the corrosion defect beneath the Corrosion Pipe Spring™ (Gages 1 and 2 in Table 1)

Eighteen (18) biaxial strain gages were installed on the carrier (base) pipe and Pipe Springs™ as shown in the tables below. Table 1 and Table 2 provide the locations of the 17 strain gages located on Corrosion Pipe Spring™ and Effective Modulus Pipe Spring™ systems, respectively. The 18th strain gage was installed on the base pipe halfway between the Effective Modulus Pipe Spring™ and the endcap girth weld to provide a measure of the unreinforced pipe strains. The two (2) strain gages installed in the corrosion defect are shown in Image 1.

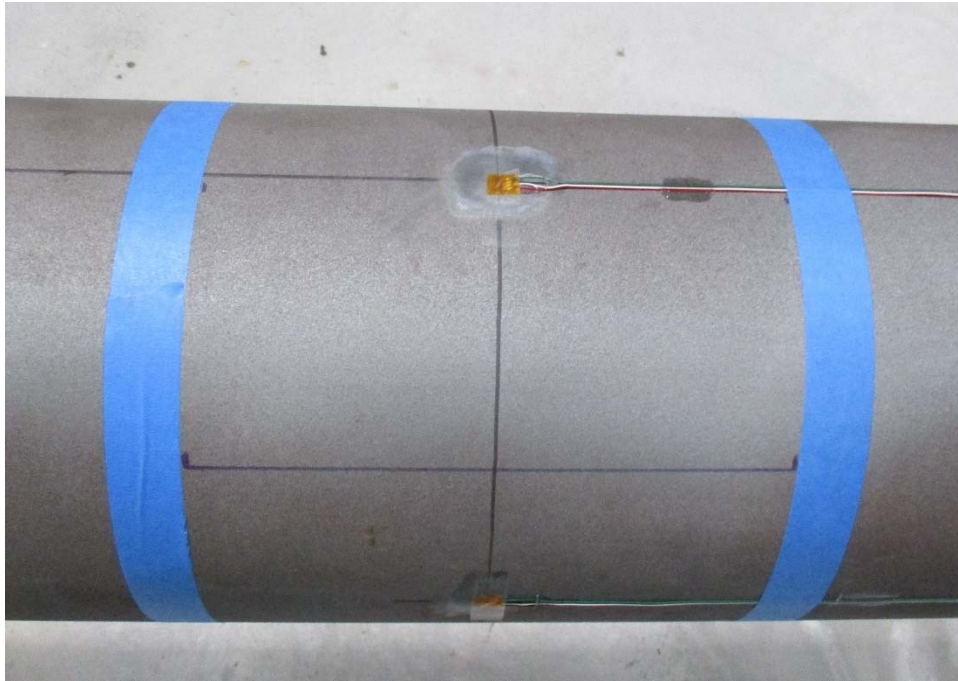
Image 2: Biaxial strain gages installed beneath the Effective Modulus Pipe Spring™ (Gages 1 through 4 in Table 2)

Three (3) gages were installed between the layers of the Effective Modulus Pipe Spring™ to characterize the stress through the repair during pressure testing. The thickness of the strain gage wires for all gages was 0.037-inches. Gages 1 through 4 in Image 2 were installed beneath the Effective Modulus Pipe Spring™ provided the strain measurements for calculation of the hoop stress. Image 2 illustrates these four (4) gages installed on the base pipe prior to installation of the Pipe Spring™.

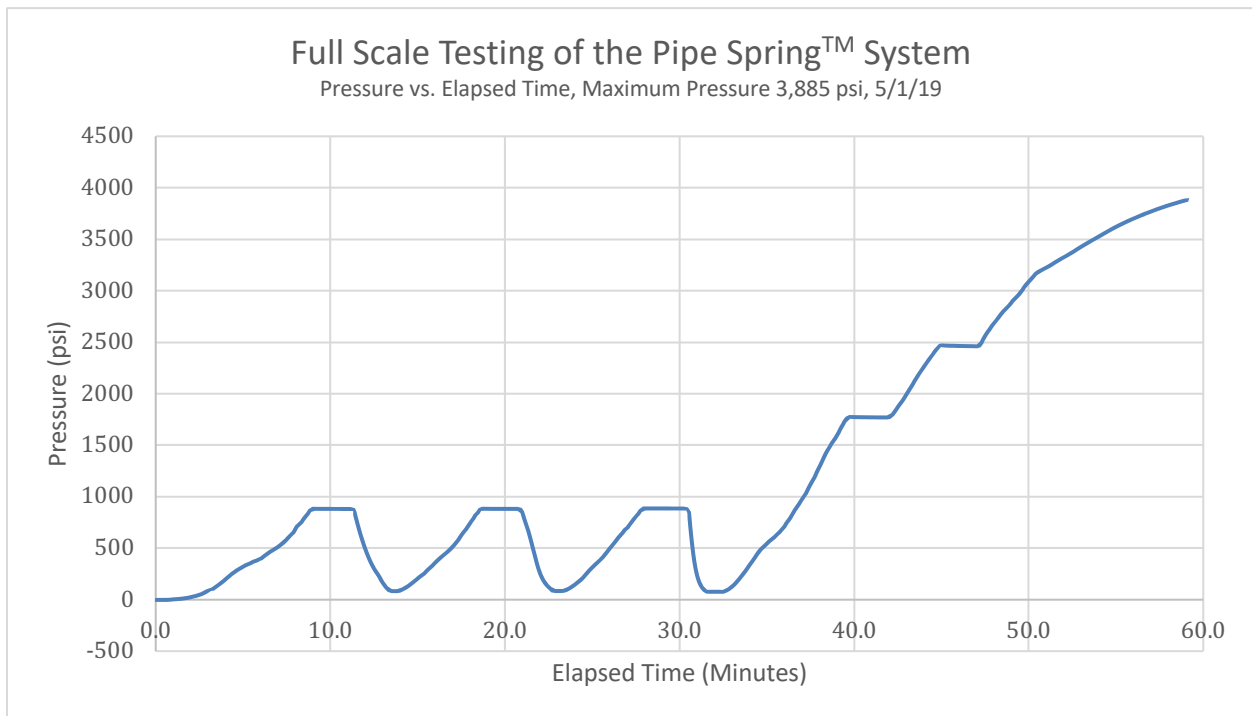
Figure 1 provides the internal pressure profile of the test program. A few cycles were included at 36% of SMYS or 890 psi. The pressure held for 2 minutes. Then, the pressure increased to 72% of SMYS or 1779 psi with a 2-minute hold. Next, the pressure was increased to 100% of SYMS, 2470 psi, with a 2-minute hold.

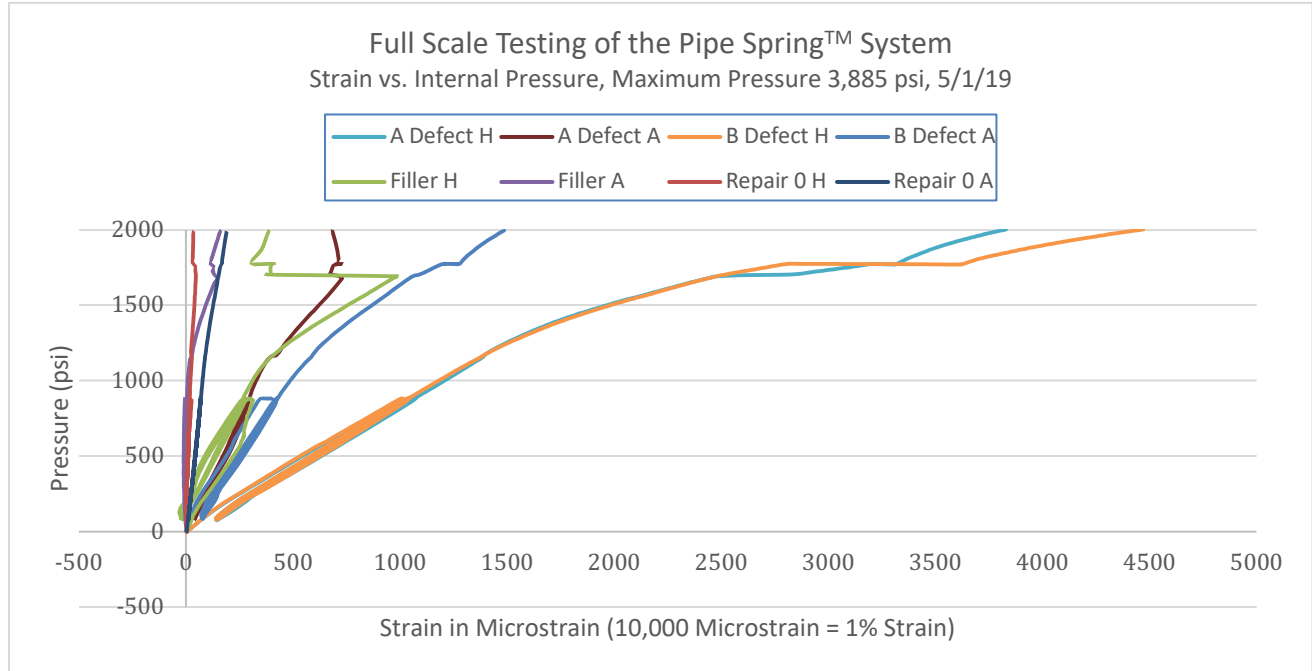
Figure 2 shows the 77% wall loss defect behavior. Two strain gauges were placed in the bottom of the 77% wall loss defect. At MAOP, 1779 psi, the average strain at the defect was 3488 micro-strain. This is well below the suggested ADV Integrity Key Performance Indicator (KPI) of excellence of 4000 microstrain for this defect configuration.

- 1) A 77% wall loss defect with an 8-inch length and 6-inch width was restored to a capacity well above the potential operating range of the pipe. The SMYS of the pipe was 2470 psi. The MAOP (72% of SMYS) was 1779 psi. The defect successfully held until 3885 psi. This represents a pressure of 218% of the MAOP and 700 psi above the yield point of the unrepaired base pipe.

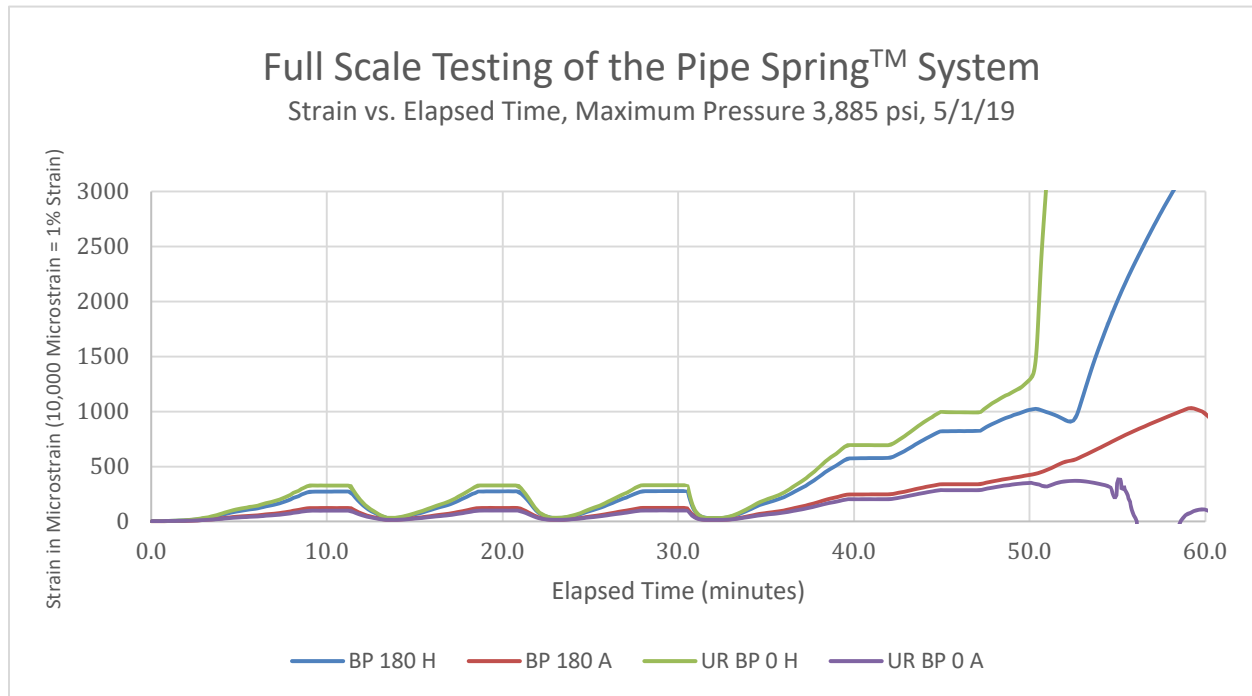
Figure 3 shows the strain developed within the interlayer strain gauges, the unrepaired base pipe performance, and the pipe under the Pipe Spring™ system. Performance of the pipe is greatly enhanced.

- Interlayer strain gauges indicate load sharing essentially immediately as the pipe experienced internal pressure (below 100 micro strain in the base pipe).
- At MAOP, 1779 psi, the stain in the pipe under the Pipe Spring™ system was 5.5% below the stain in the unrepaired base pipe.
- At SMYS, 2470 psi, the stain in the pipe under the Pipe Spring™ system was 6.5% below the strain in the base pipe.
- At the actual yield of the unrepaired base pipe (3184 psi) the strain in the pipe under the Pipe Spring™ was reduced by 42.2 %.
- At 10,000 microstrain of the base pipe (3445 psi, 140% of SMYS) the strain in the pipe under the Pipe Spring was reduced by 80.0%

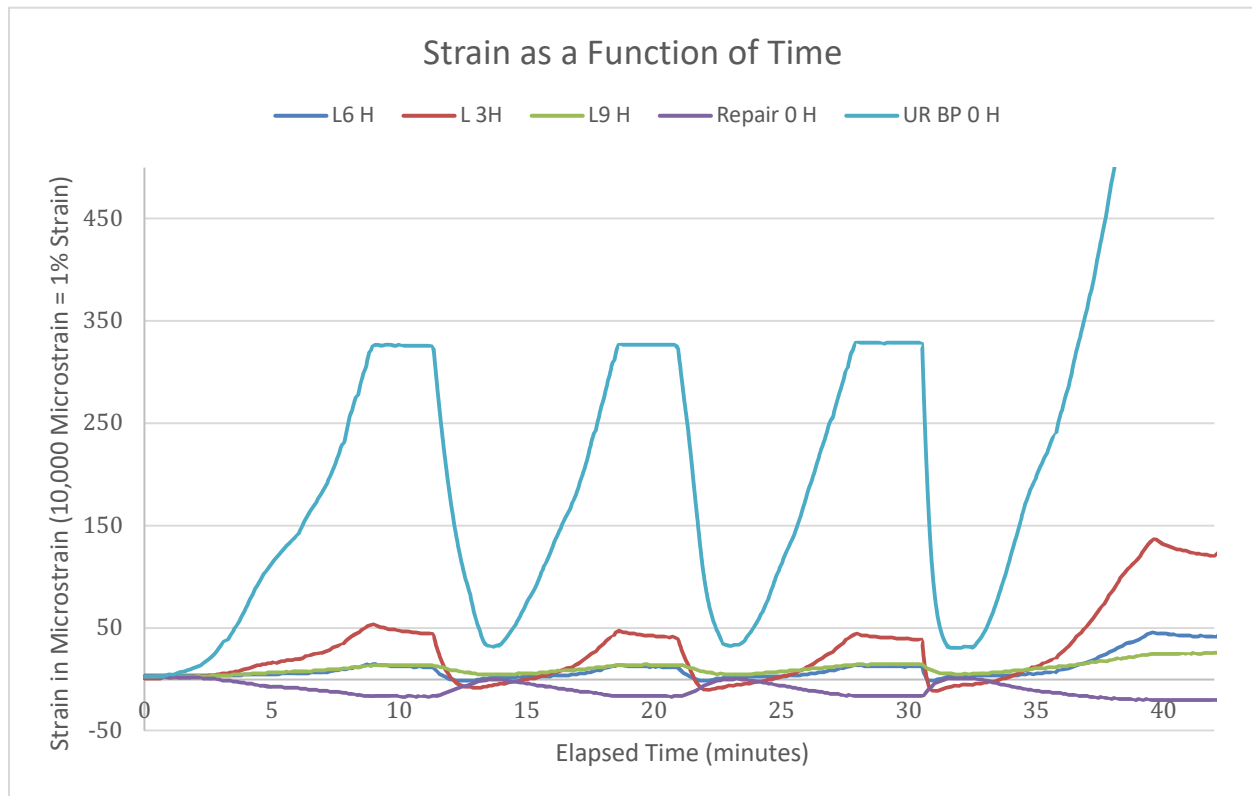
Figure 4 shows the behavior at very low pressure and strain. The results indicate that the Pipe Spring™ shares stress with essentially no delay.
